Case Study: The Shop in the Lawnmarket and other Edinburgh Shop Frontages

Ian Riddell

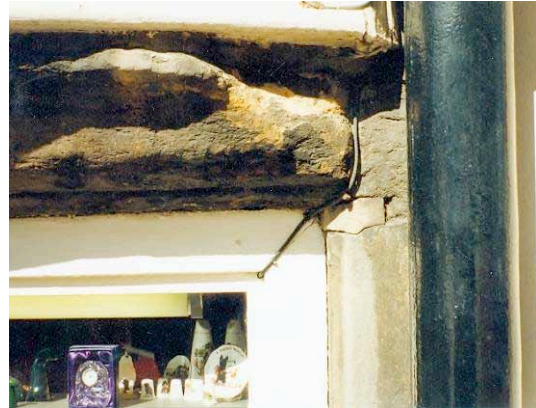
The Edinburgh Old Town Renewal Trust funded the project to restore the shopfront with a grant of 66%, which was the level 11 years ago. Our Client advised that we must reinstate the display boxes. Our particular concern was with the defective lintel caused by water running off the window resulting in the stonework becoming cracked and spalling off.

Damage to lintel above basement door

An honest repair of the defective stone lintel over the doorway was carried out. It was decided that it would be better for the future of the building to curve the lintel back to the line of the bow frontage rather than to project in front of the window to improve the weathering of the stone although this was different from the original construction.

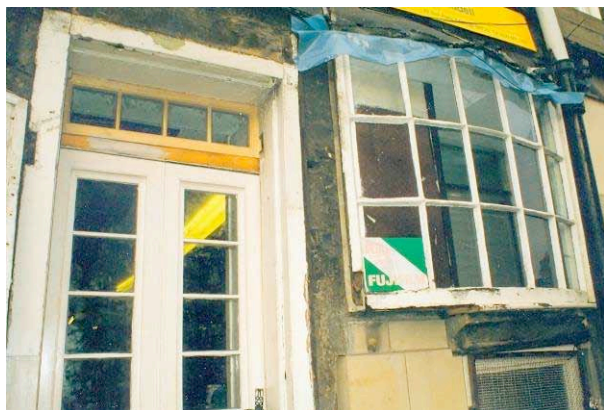
Shopfront under repair

The fascia and cornice were completely rotten but we prepared drawings recording the construction including tongue and groove joints. Prepared working drawings for use by contractor were also drawn up. It was important to be faithful to the original construction and materials and we sourced the best timbers using Douglas Fir as pine was used in the original construction.

There was an inherent problem with timber rot arising from condensation so we introduced for ventilation holes between timber soldiers behind the cornice and we also included ventilators into the roof, constructed in lead, to allow permanent ventilation and to preserve the life of timbers.

The contractor wanted to take the bow window back to his workshop but we were concerned that this was more likely to lead to some damage if it was off site so we insisted that any repairs were done on site. Even elements like the putty which had built up over the years were important and we were concerned to preserve this as this told a little bit about the history of the shop.

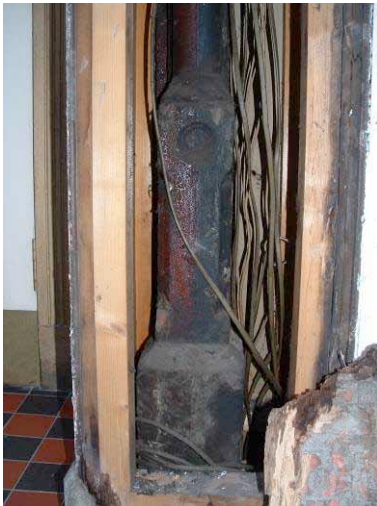
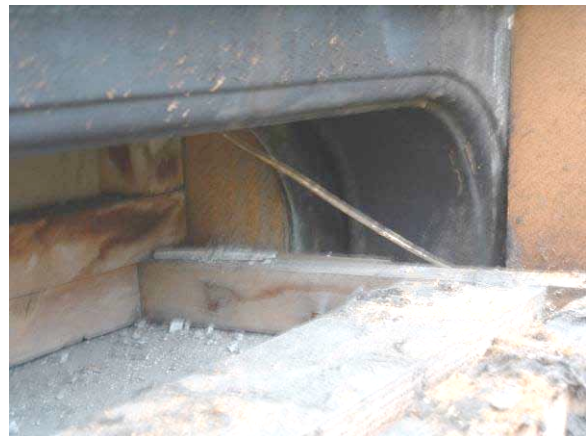
This was an Edinburgh World Heritage Trust scheme which involved stonework repairs to a tenement which included a public house on the ground floor. At the end of the project there was money remaining for shopfront improvements and underneath later alterations we found remnants of a cast iron shopfront which provided sufficient evidence of the original frontage to be able to reconstruct it.

Cast iron uncovered during investigative survey

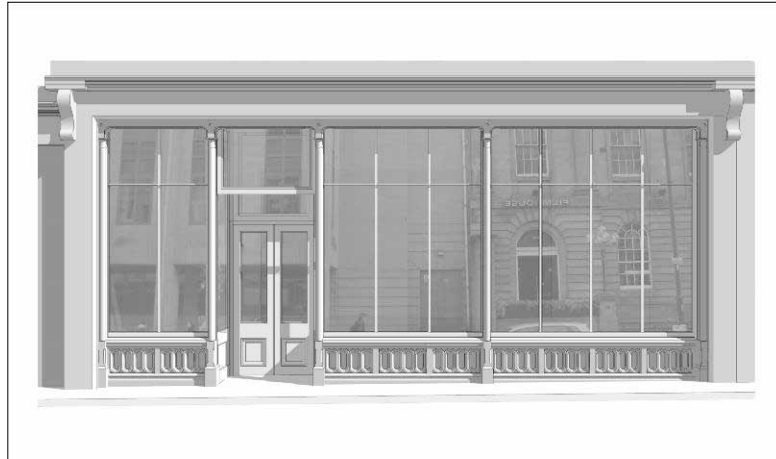
Design proposal reinstating cast iron shopfront

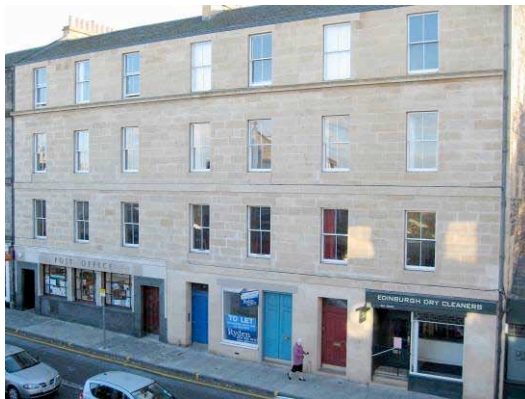
This was a comprehensive scheme for the whole building which included Edinburgh Dry Cleaners. Research was undertaken into local frontages of a similar age to put together an appropriate design for the dry cleaners new frontage. Repairs and restoration works to the Post Office frontage were completed using correctly sourced stone cladding and bronze elements for which specifications were found through information researched using the Council's Drawing Archive.

14-19 East Norton Place, Edinburgh after completion of work to stonework and shopfronts

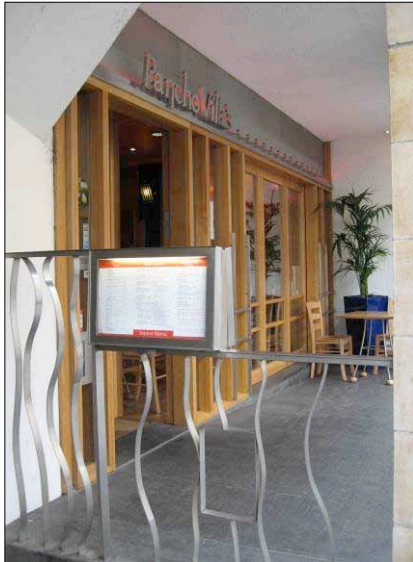
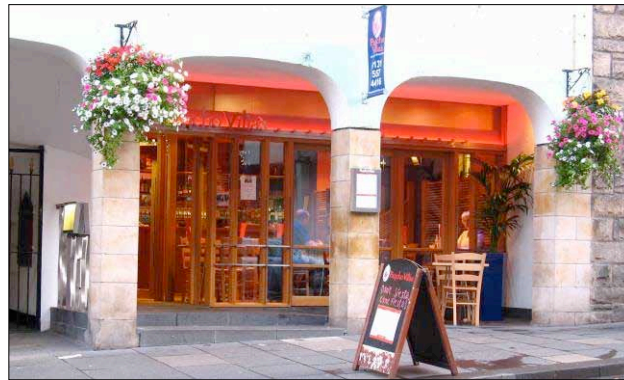
240 Canongate, Edinburgh

The solution uses oak and granite and a sloping pavement to allow wheelchair access. The frontage slides back for summer use. Materials included stainless steel for the balustrade and support for lettering with neon backlighting were used to try to advertise the premises because of its location tucked away behind the arches.
