INFORM
INFORMATION FOR TRADITIONAL BUILDING OWNERS

Structural Joinery

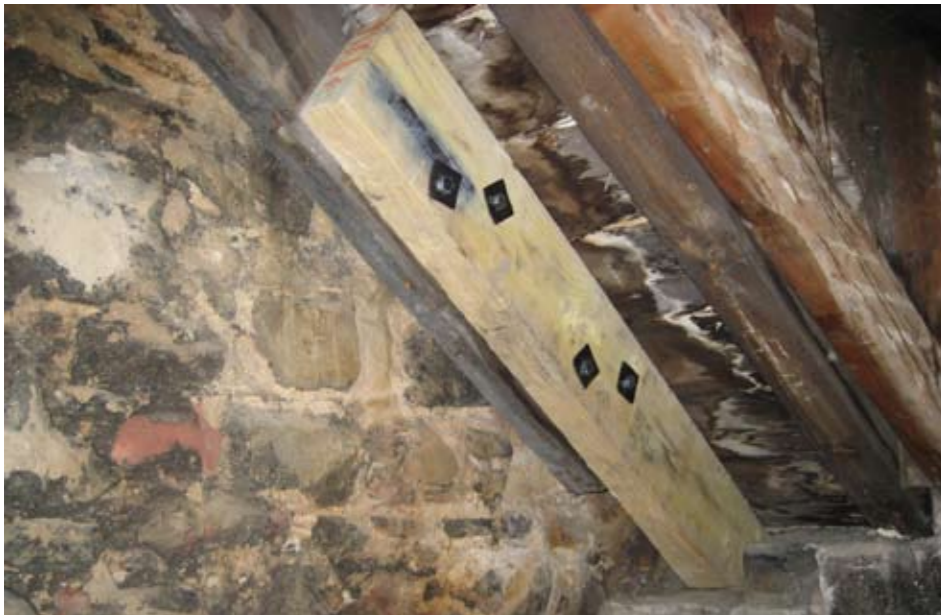
Strengthening of the joint with bolts

Areas of sound timber can become less stable by the loosening or failure of the iron nails, common at tie beams and the apex joint. Where possible the old nail should be removed if it has failed, and a stainless steel bolt and washer set fitted, remembering that old nails can assist in dating the building. Normally one bolt is sufficient for stiffening.

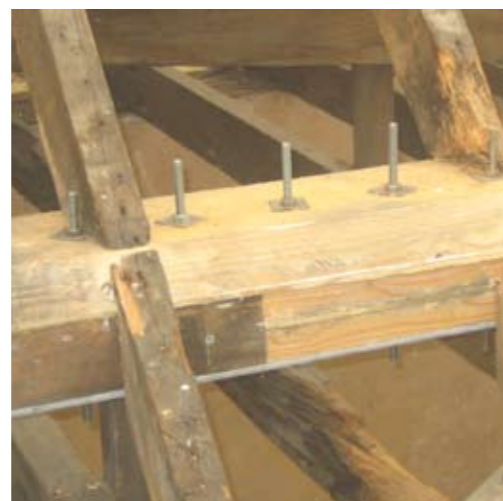
Composite repair using resin, new timber and steel plate

Resins and glues. Some engineers specify an epoxy resin to be used in structural repairs, especially in areas where the thrust is in more than one plane of the timber element (for

example valley beams). Such resin is normally a slow setting resin, giving time for the resin to soak into the matrix and fibres of the timber.

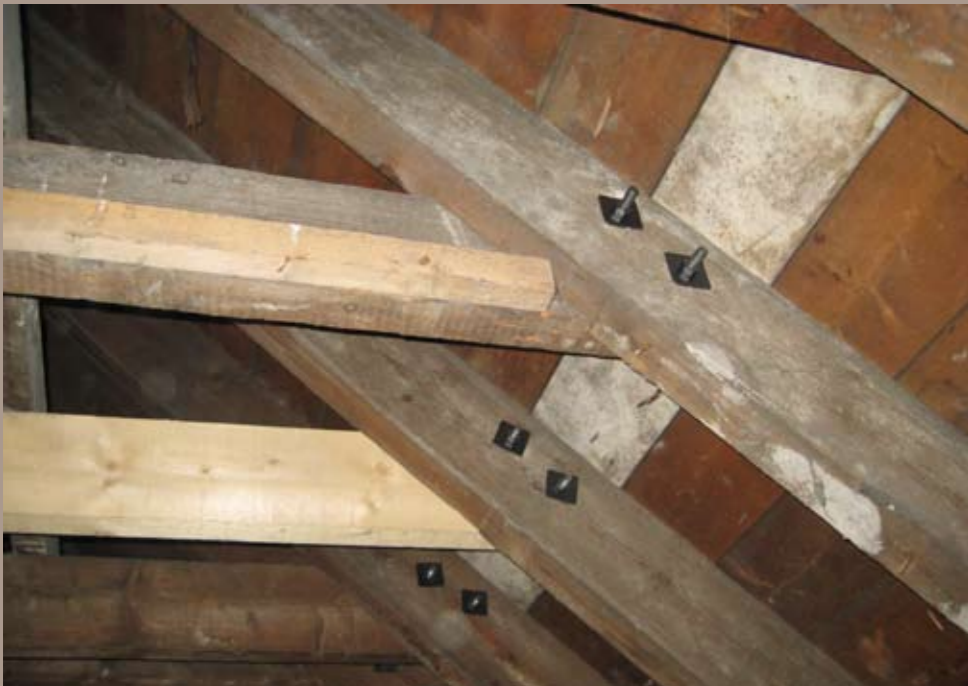
Strengthening of the joint with bolts

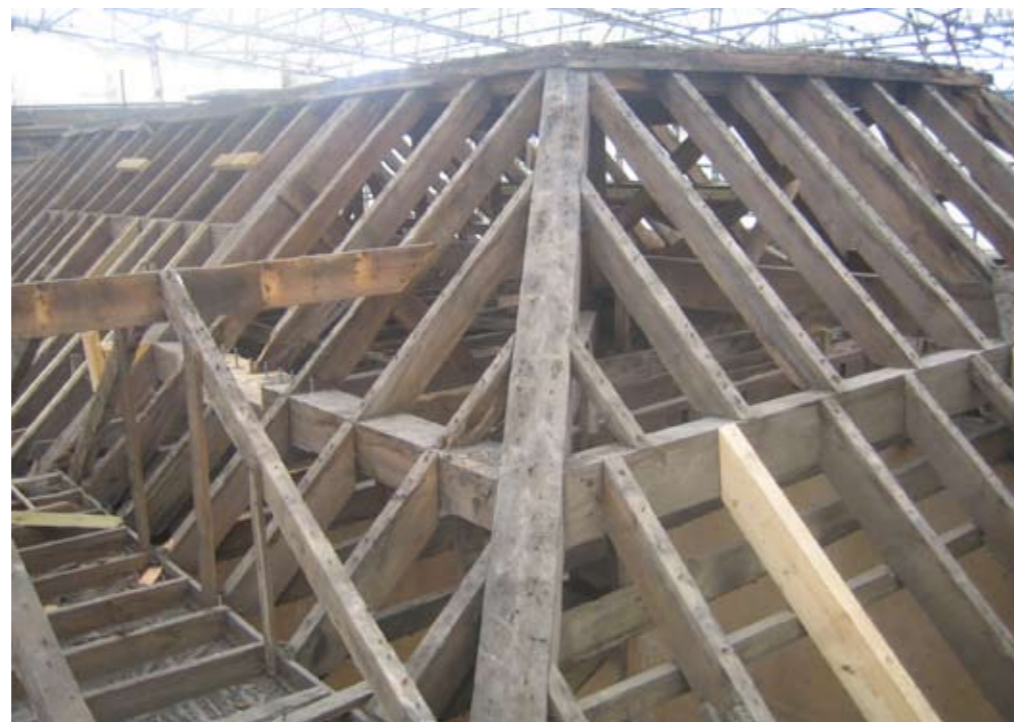
A roof of the Late 18th under repair, showing the purlins midway in the span.

In some earlier roofs, the A-frames are fewer, and joined longitudinally by timbers called purlins, shorter and smaller rafters then carry the roof. As the rafters have to carry more weight, they are referred to as principal rafters. This type of roof became rare by the 19th C, and standard A frame

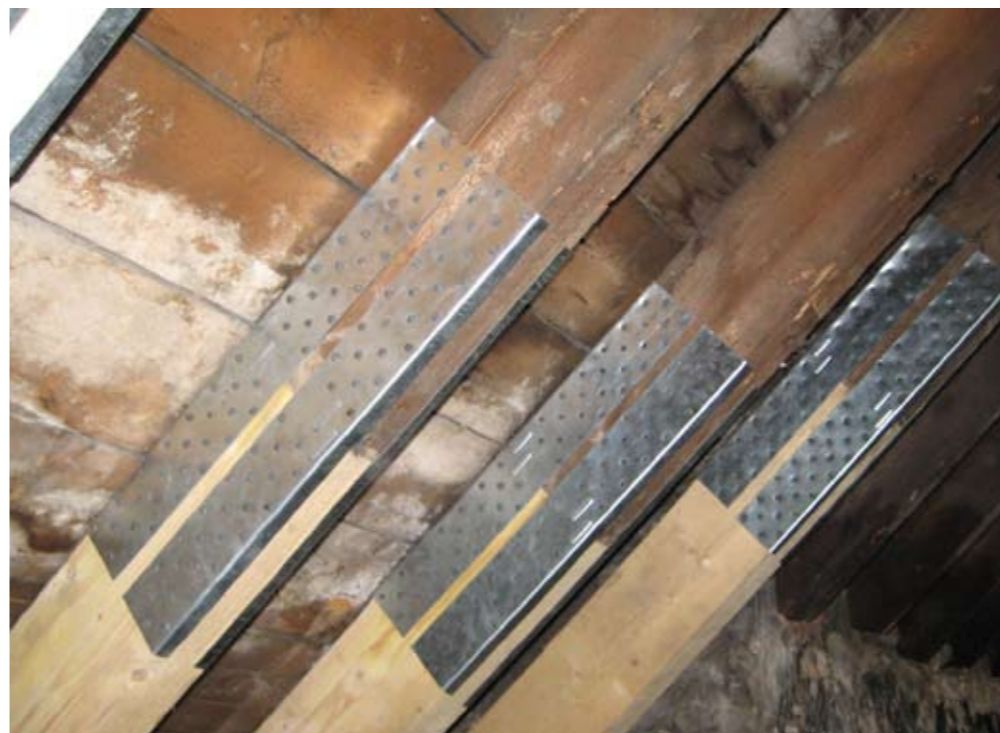
Modern metal pre drilled straps used in rafter splices.

Plating using modern steel is a similar approach, but using preformed steel plates, angled to fit the joist. They are fixed with ringshank nails. This repair is simple and

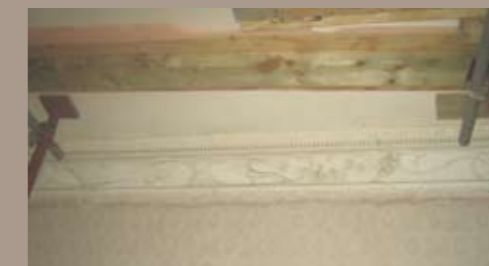
Supporting a ceiling during work on the joist ends

Floor joists, while very durable in a dry properly maintained wall, are very vulnerable in a wall that has become saturated as wet or dry rot will quickly compromise the structural integrity. (such decay can be localised, and largely invisible, although settlement and distortion of the floor should give an indication). Repair techniques are the same as for roof timbers, although removal of boarding will be required. Where possible, repair such elements from above or below to avoid unnecessary destruction.
